**Home Energy Evaluation Report
for
House Six**

House Six
Canterbury Woods Community
Annandale, VA

Inspection Date: June 12, 2010

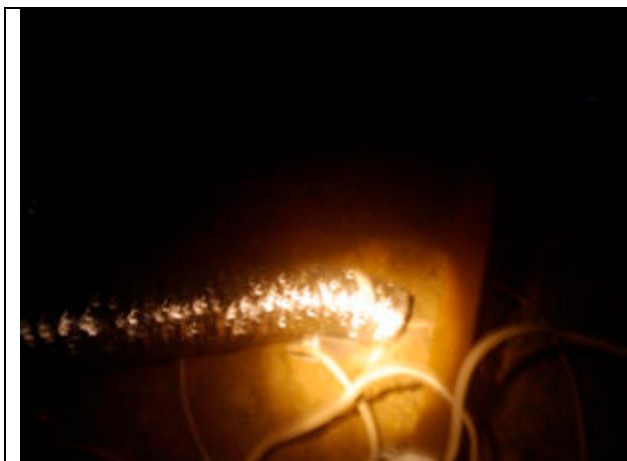
Bath exhaust fans are not extended to exterior

- 1) Remove whole house fan and install sealed and insulated attic hatch (repair framing).
- 2) Remove roof power ventilator.
- 3) Terminate bath exhaust fans through the roof.
- 4) Seal ducts located in attic.
- 5) Seal wall top plates and all penetrations between the attic and 2nd floor ceiling.
- 6) Insulate the attic to R-49 thickness.

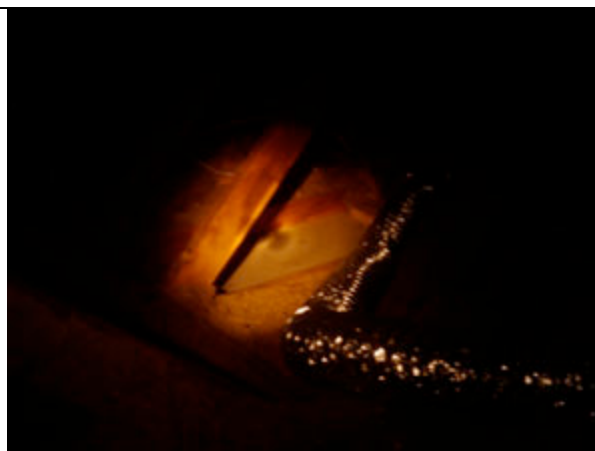
Area of insulation missing – see bathroom picture below

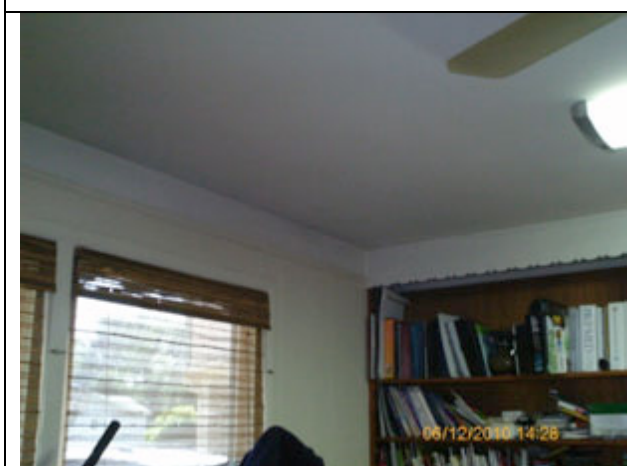
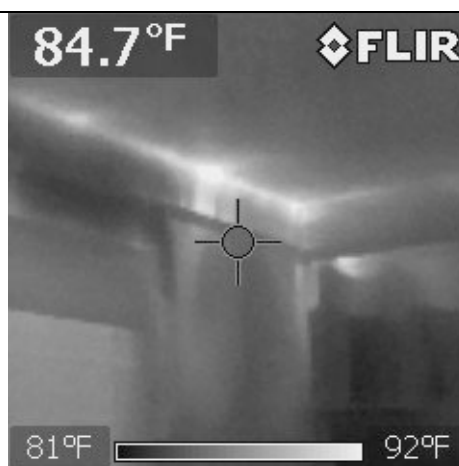
Air leakage at top plates of walls

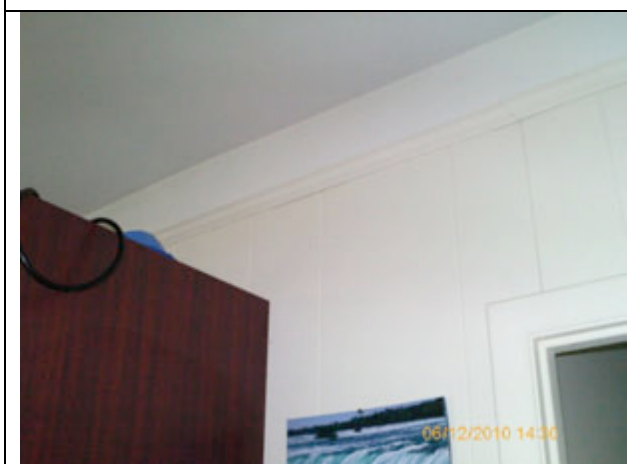
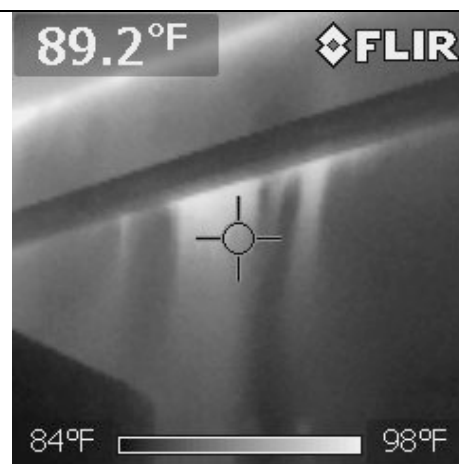
Air leakage between paneling and trim

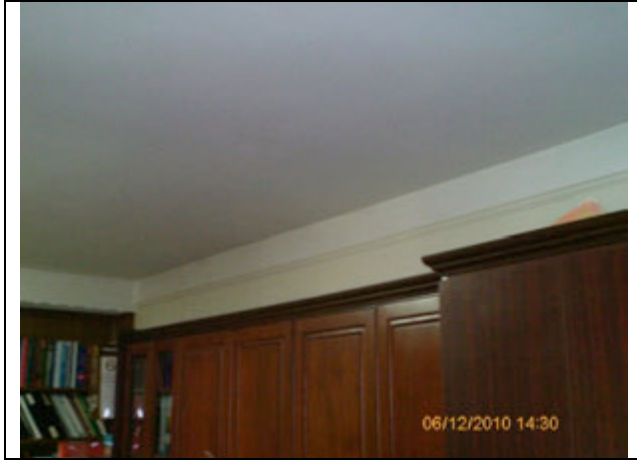
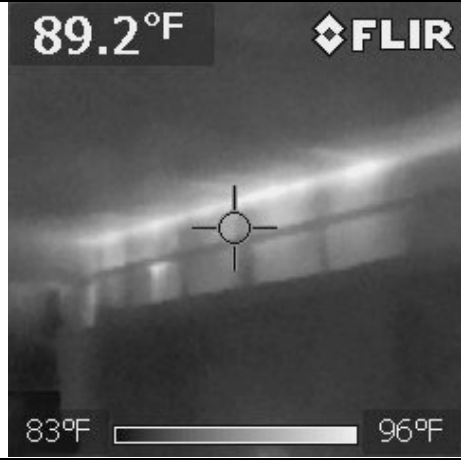
Top plate air sealing needed

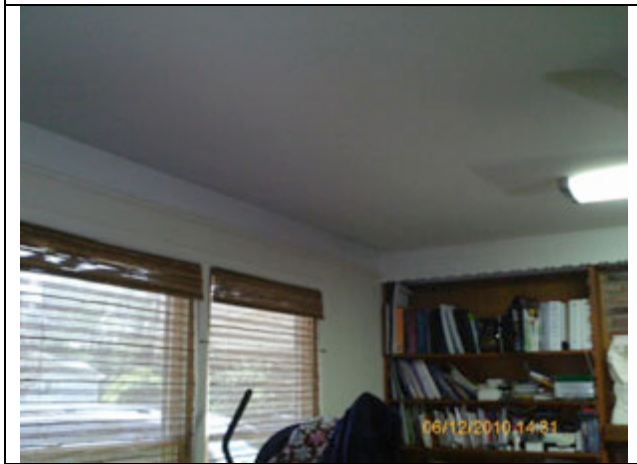
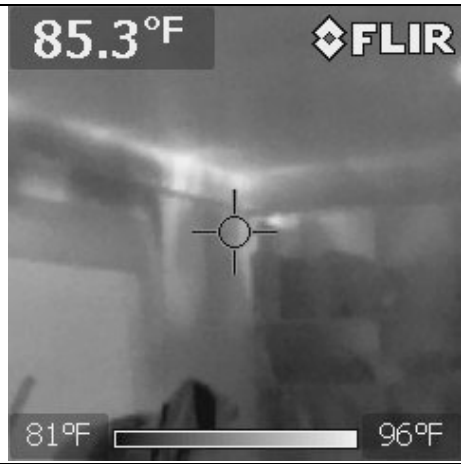
Top plate air sealing needed

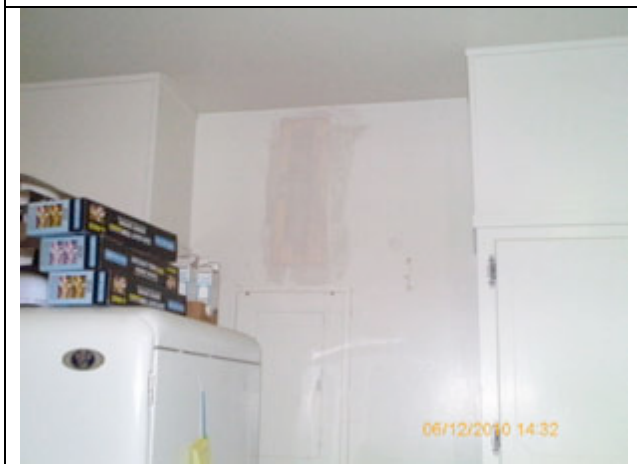
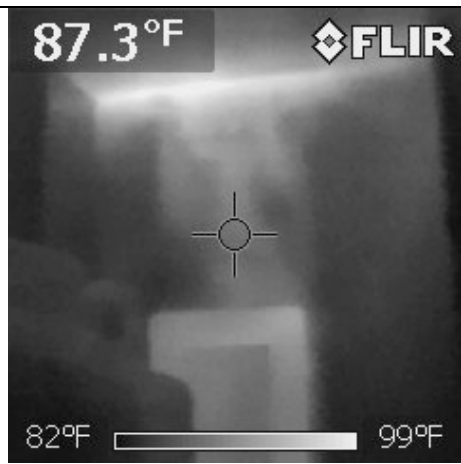
Leakage at top plates where electrical wires penetrate framing

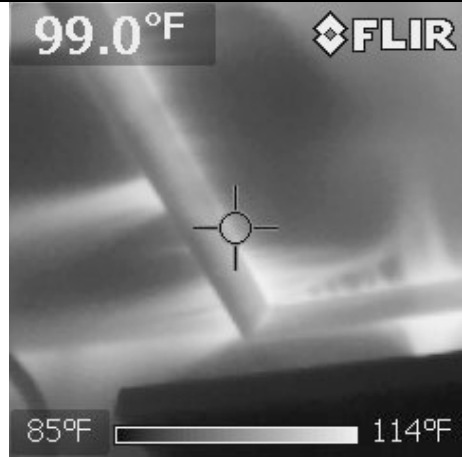
Small attic access panel in pantry

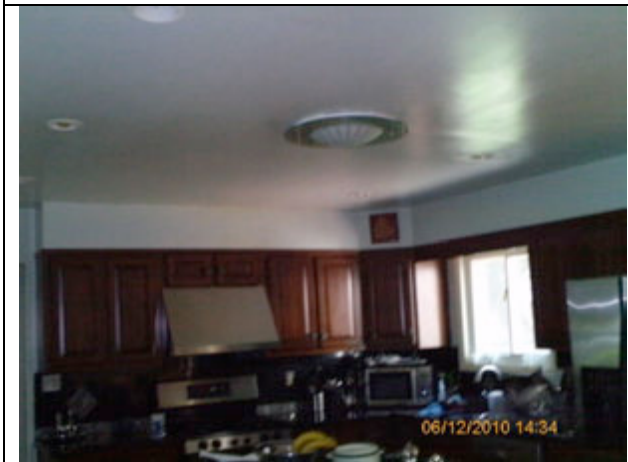
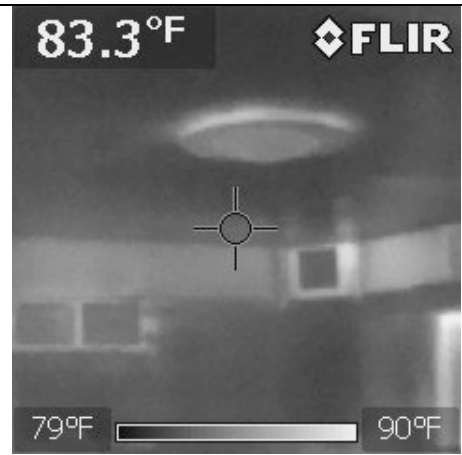
Leakage at dropped soffit and light fixture

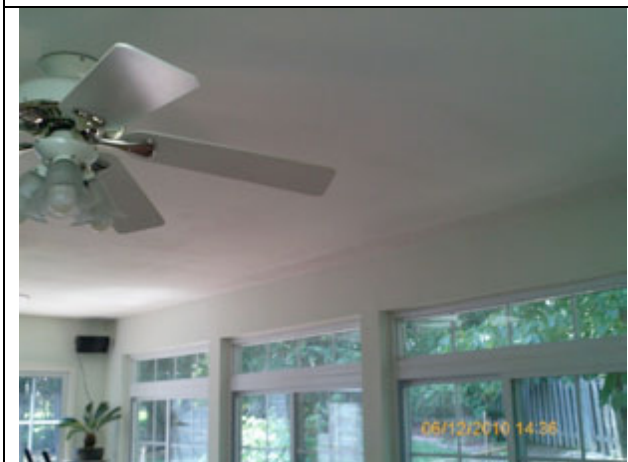
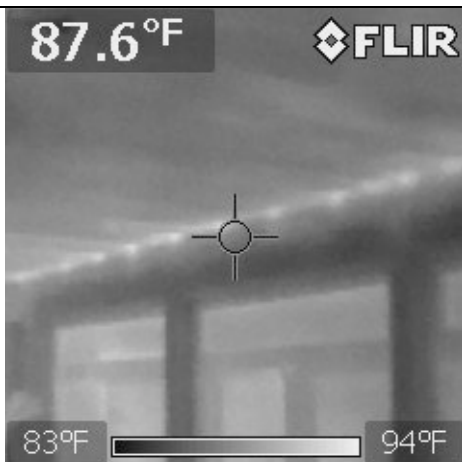
Enclosed space top plate leakage – not much to do here without creating a hole to this attic

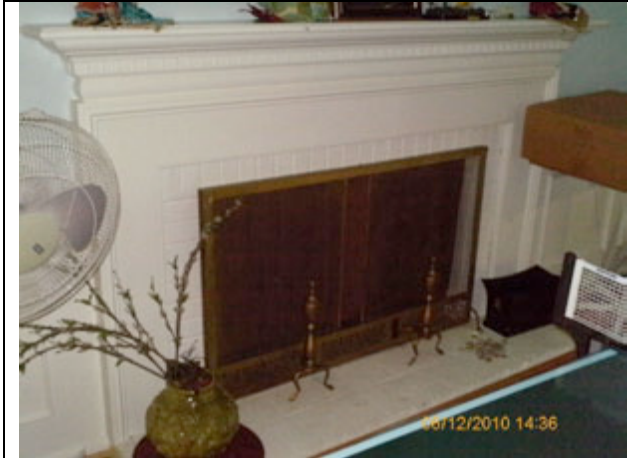
Fireplace can be capped at top with operable damper

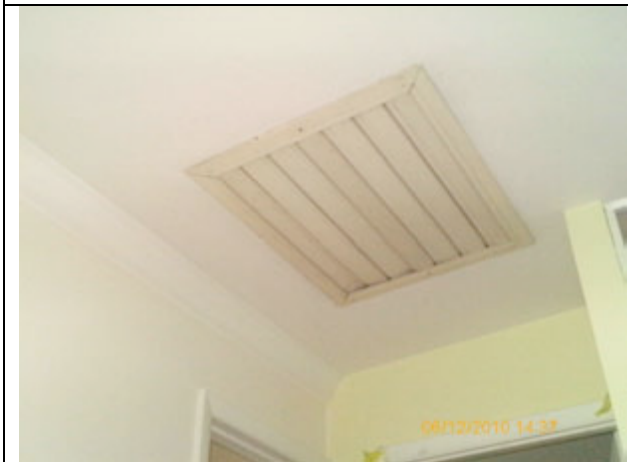
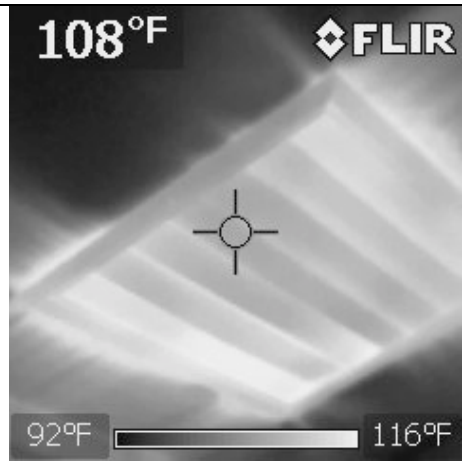
Whole house fan thermal bypass

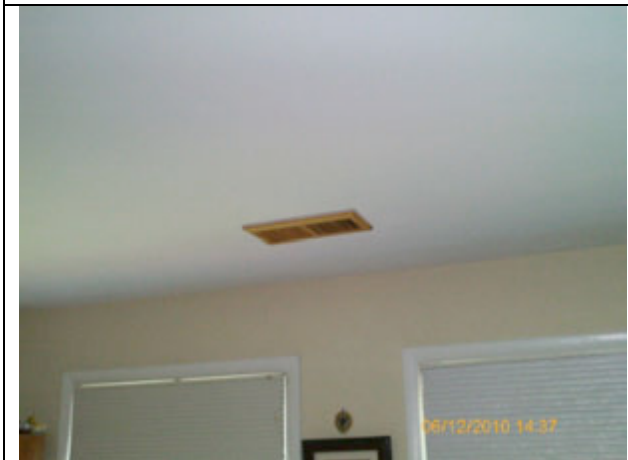
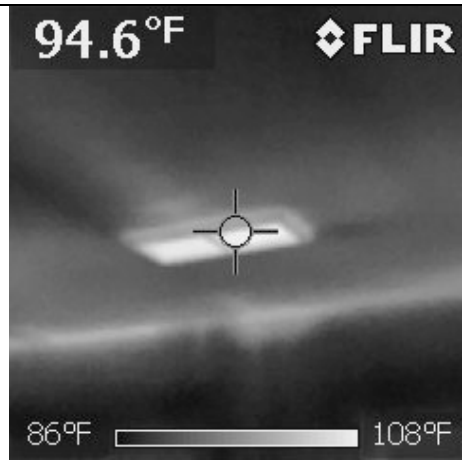
Top plate and duct leakage

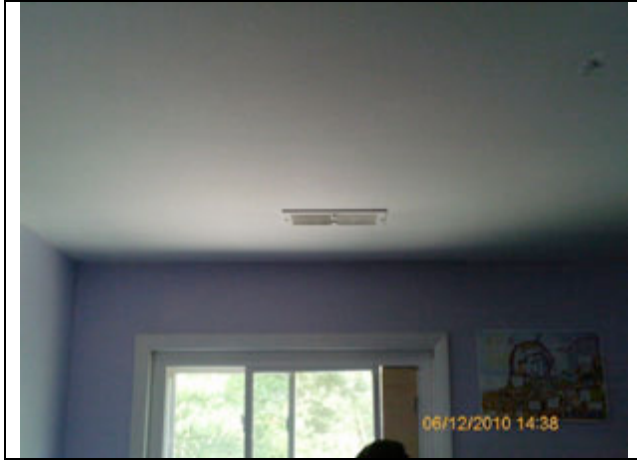
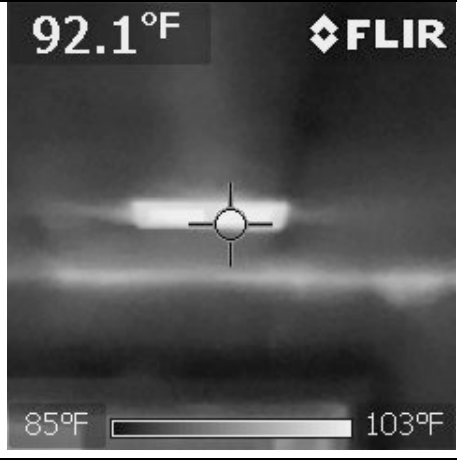
Duct leakage and top plate leakage

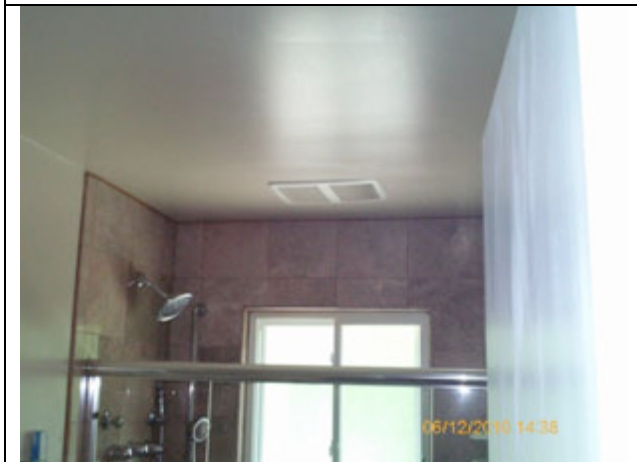
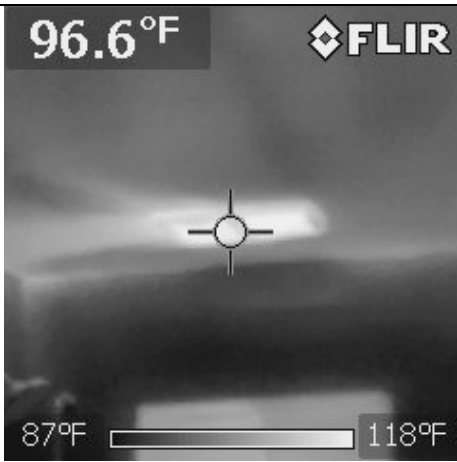
Exhaust fan connected to attic – could create moisture problems in addition to the air leakage

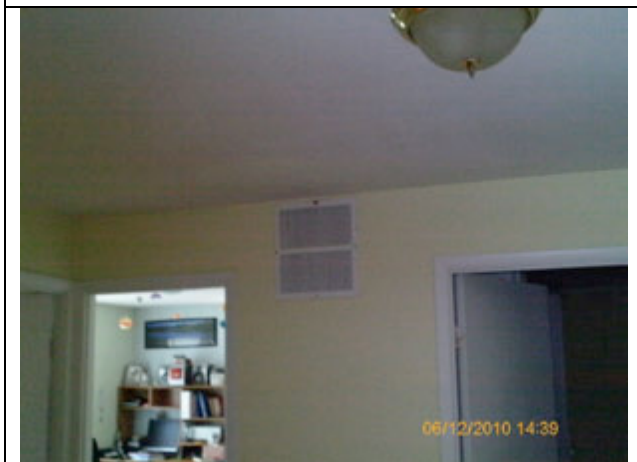
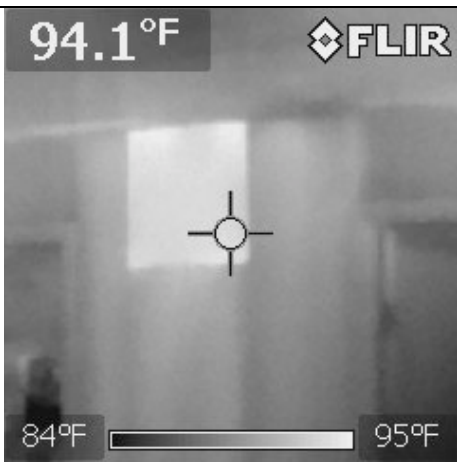
Leakage at attic duct work

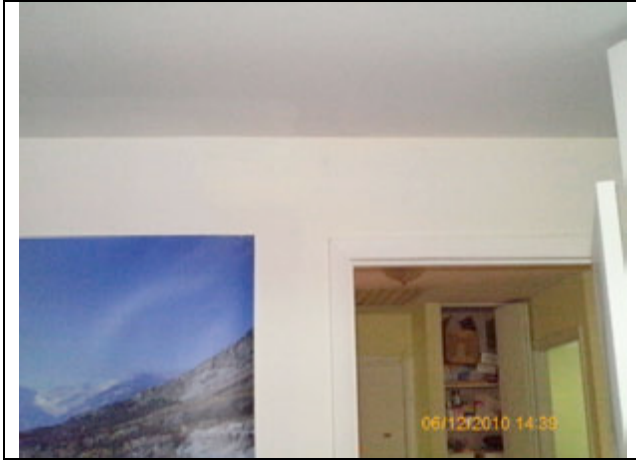
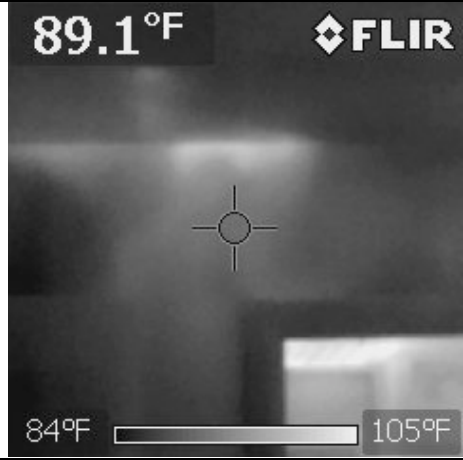
Top plate leakage

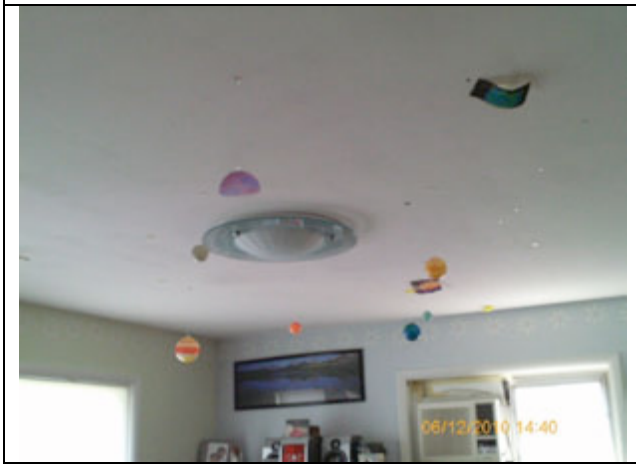
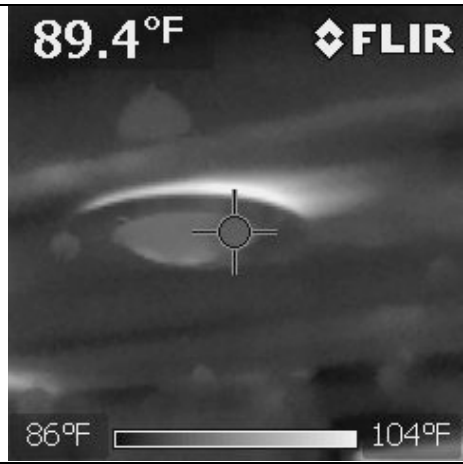
Leakage thru electrical box

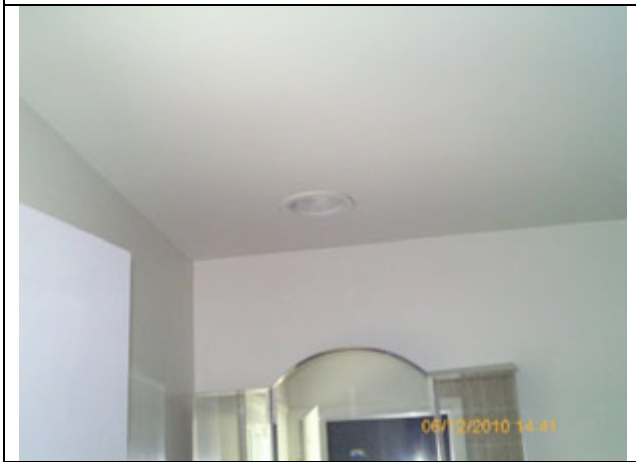
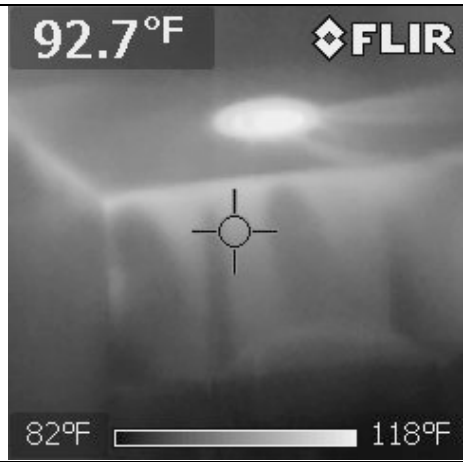
Recessed light and top plate leakage

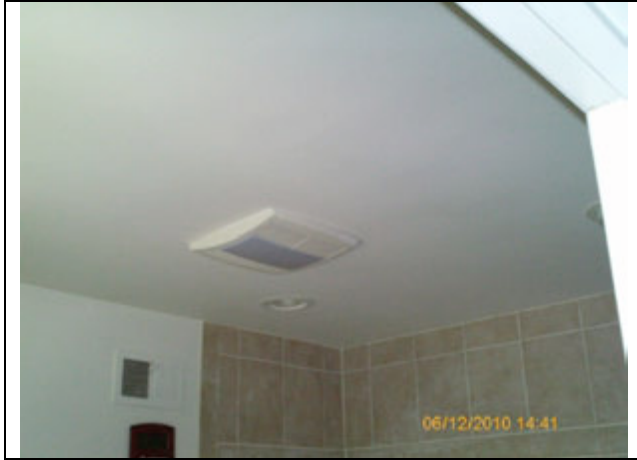
Fan exhaust to attic

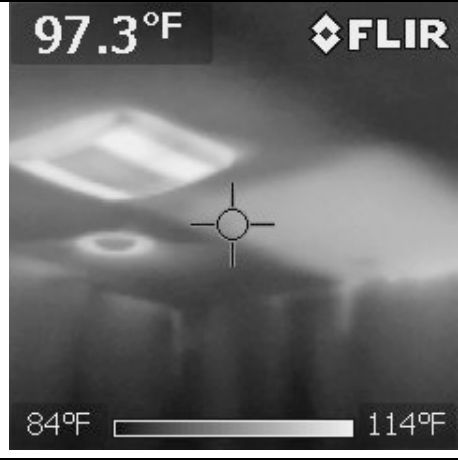
Exhaust and recessed light leakage, missing insulation
