# Home Energy Evaluation Report for House Four

House Four  
Canterbury Woods Community  
Annandale, VA

**Inspection Date:** June 10, 2010

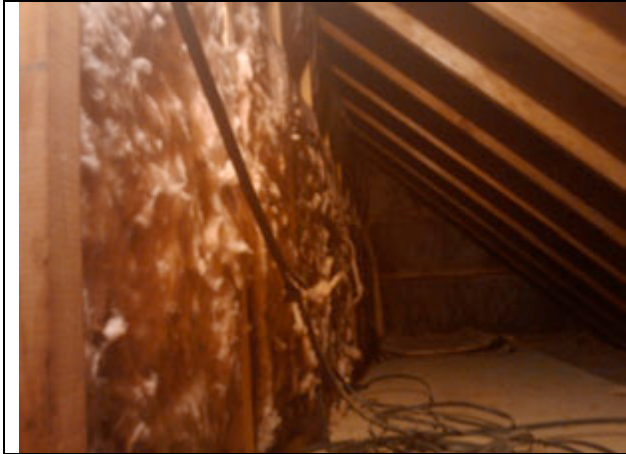
Attic knee wall without a sealed air barrier

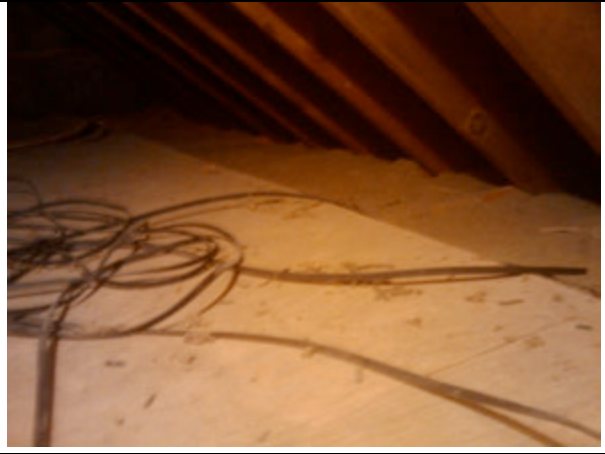
Low insulation in small attic

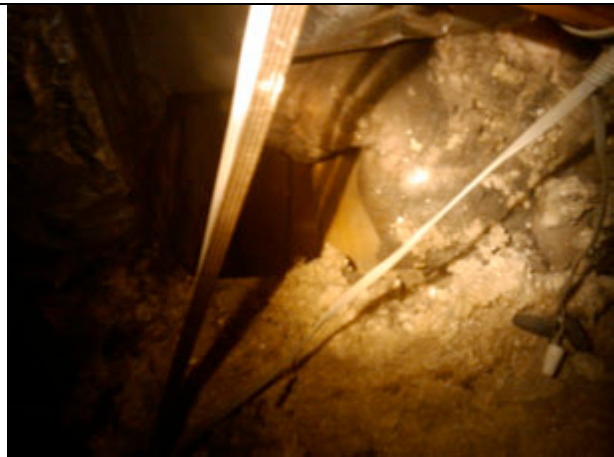
Open duct chase from side

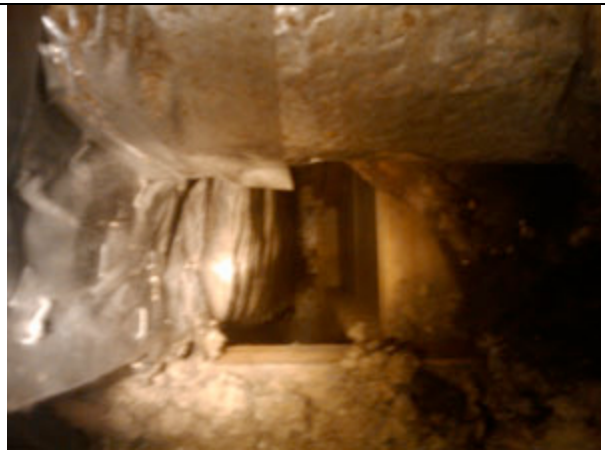
Open duct chase from top

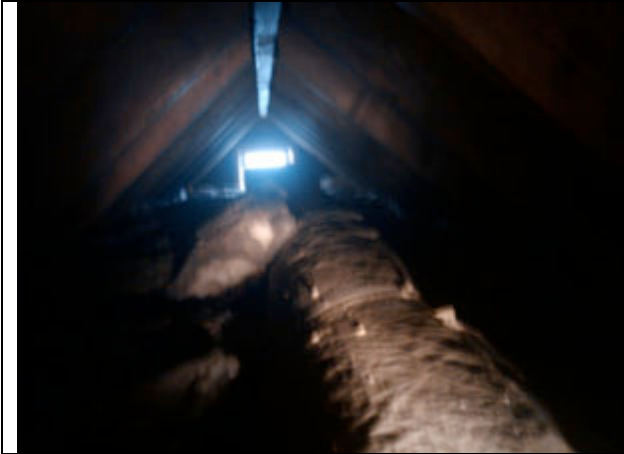
Small attic above finished room

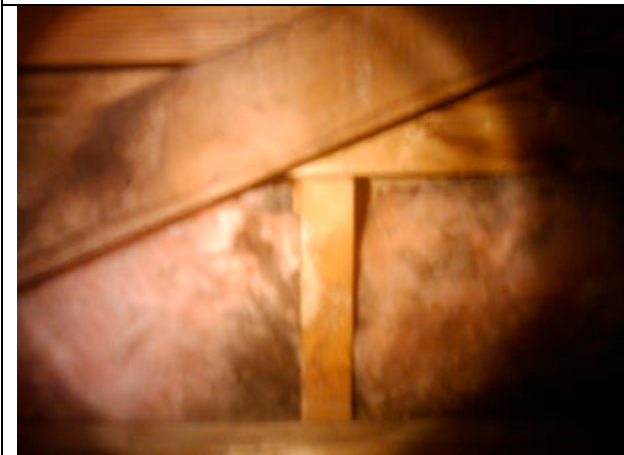
No air barrier between garage attic and living space  
note dirty insulation

- 1) Install air barrier between garage attic and living space.
- 2) Seal electrical boxes located in the exterior envelope.
- 3) Install air tight recessed light trims if available (depends on manufacturer).

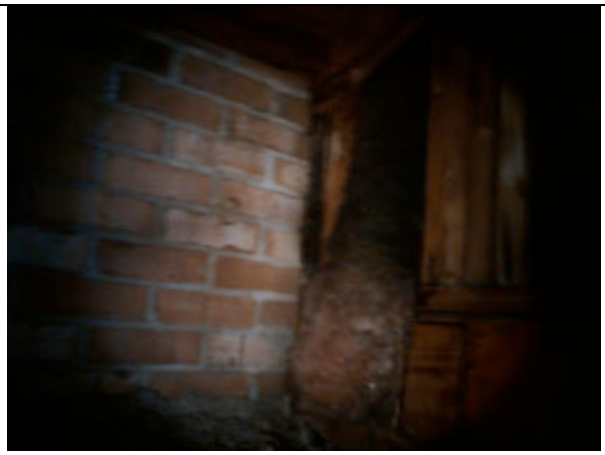
Thermal bypass from living space to garage attic

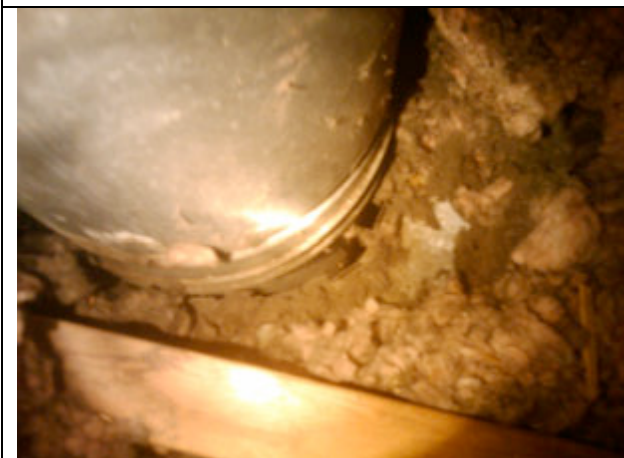
Seal flue chase

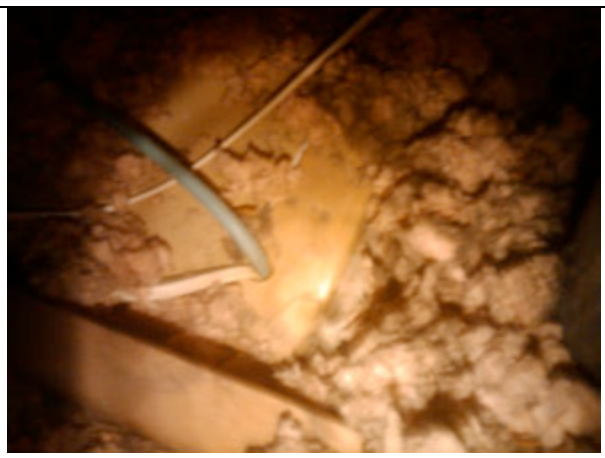
Seal top plates of walls and wire penetrations

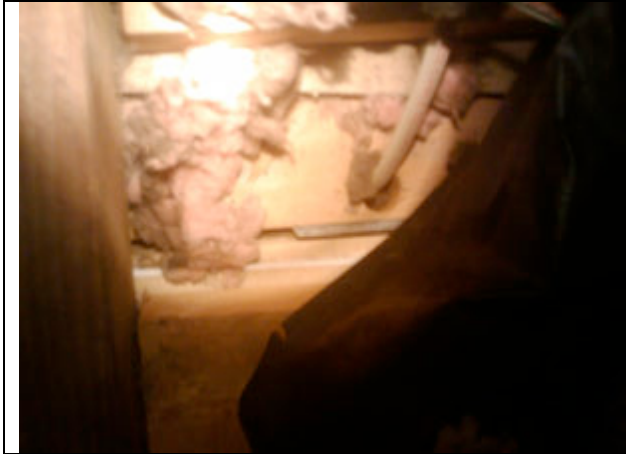
Seal top plates of walls and wire penetrations

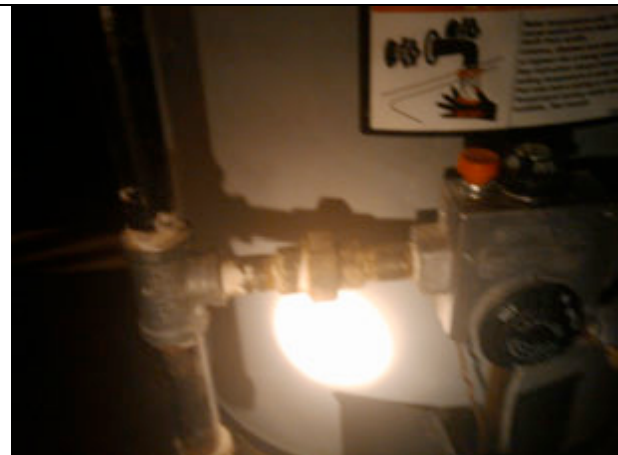
gas leaks were detected in the gas lines. ***These should be tightened by a qualified service company before any home envelope sealing is undertaken.***

Small gas leak detected – have checked by licensed plumber/gas fitter

- 1) *Have plumber check and tighten gas pipe fittings – leakage detected in two locations, see pictures*
- 2) Install furnace filter in return duct slot
- 3) Air seal and insulate attic hatch
- 4) Terminate bath exhaust fan to exterior
- 5) Install insulated air barrier at attic knee walls – 3 sides of bedroom (1 above garage)
- 6) Air seal penetrations in ceiling/attic interface (pipes/ducts/electrical)
- 7) Seal ducts located in unconditioned space
- 8) Insulate attic to R-49
- 9) Seal penetrations in exterior walls

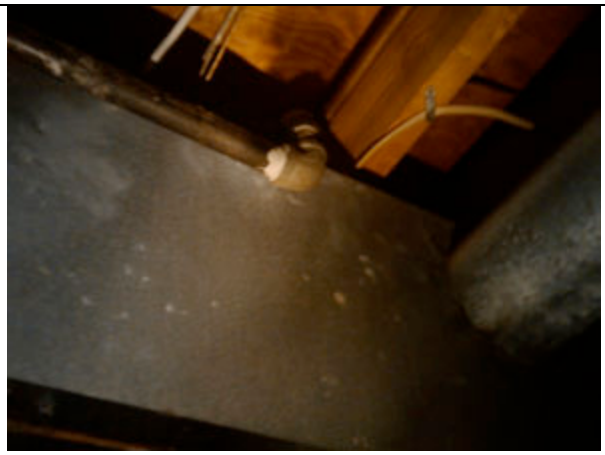
Small gas leak detected – have checked by licensed plumber/gas fitter

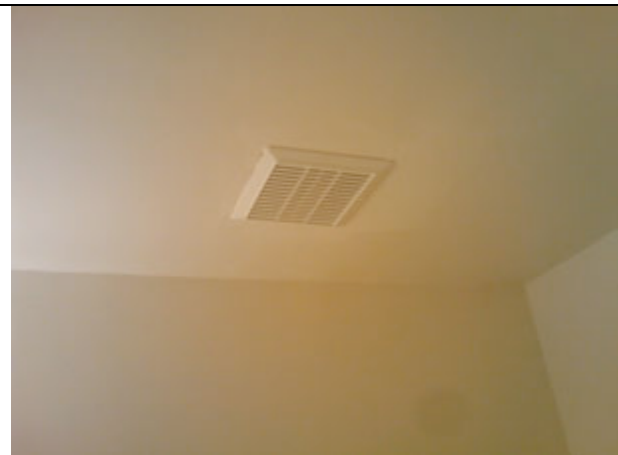
Bathroom vent connected to attic

- 1) Air seal and insulate the attic hatch.
- 2) Terminate bath exhaust fan through the roof.
- 3) Seal wall top plates and all penetrations between the attic and 2<sup>nd</sup> floor ceiling.
- 4) Insulate the attic to R-49 thickness.
- 5) Seal ducts located in attic.

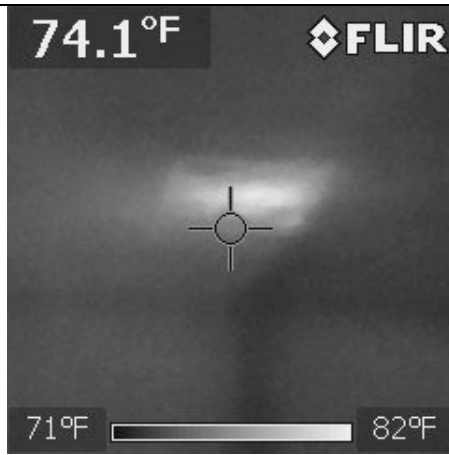
Infrared of vent showing air movement

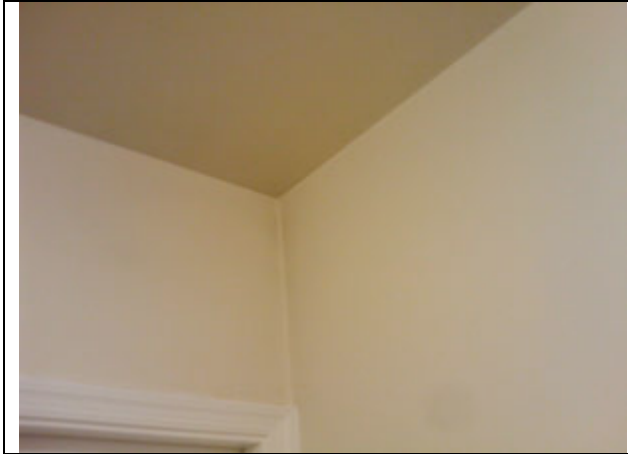
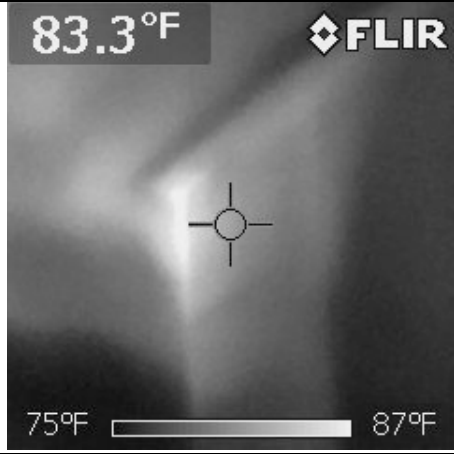
Air movement – top plates need air sealing

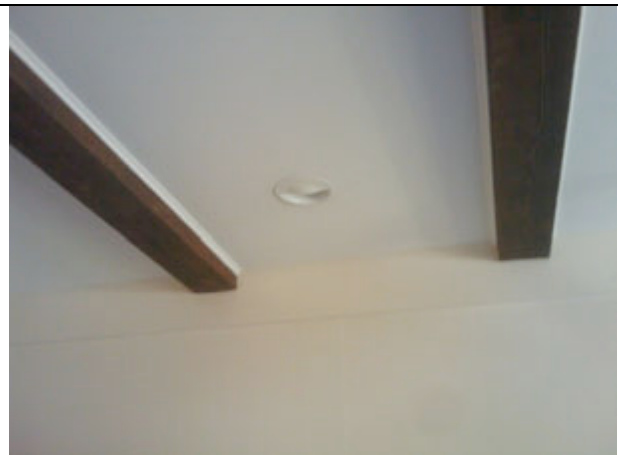
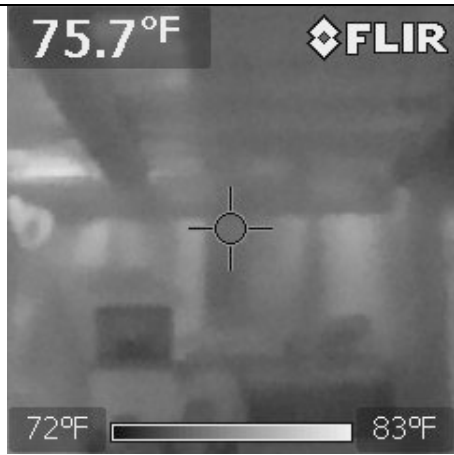
Infrared showing connection to garage and garage attic

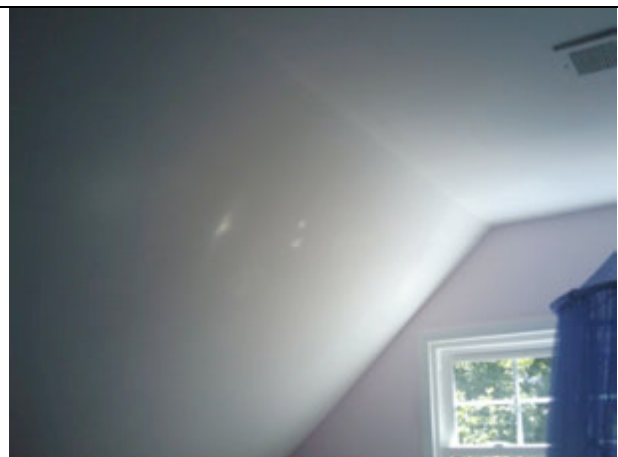
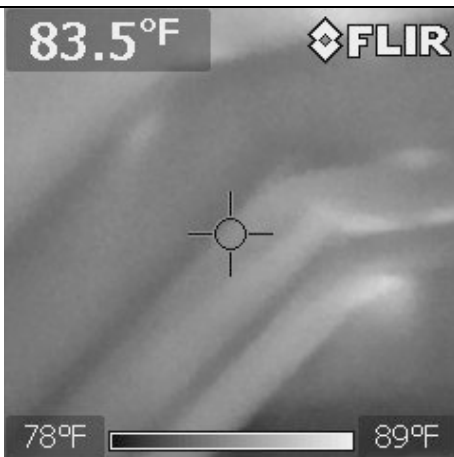
Air movement above bedroom

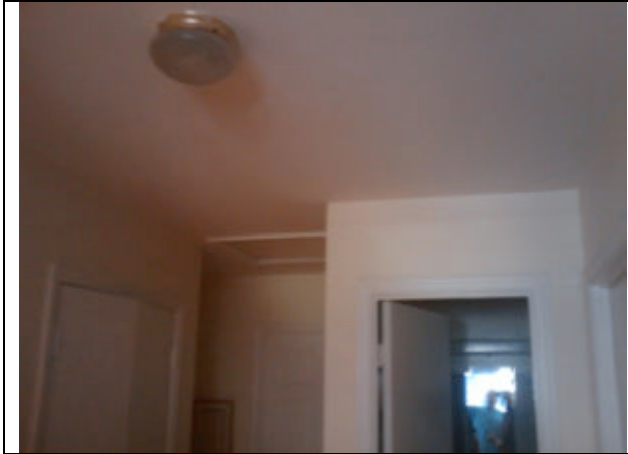
Upstairs hallway and attic hatch

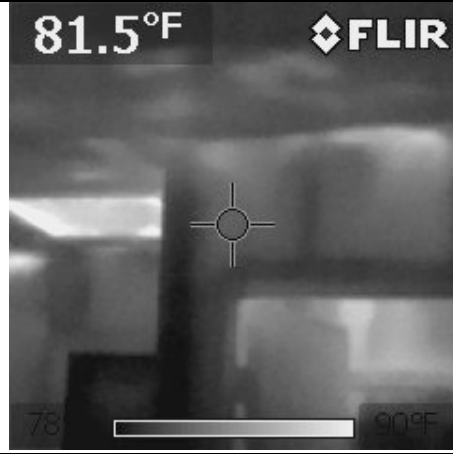
Attic hatch sealing, top plate sealing, increased insulation levels needed

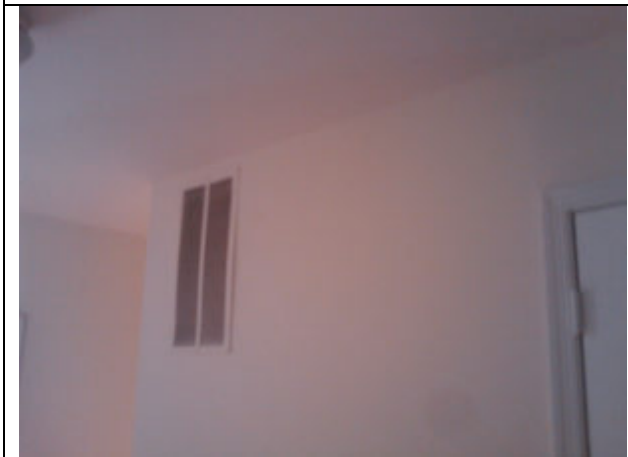
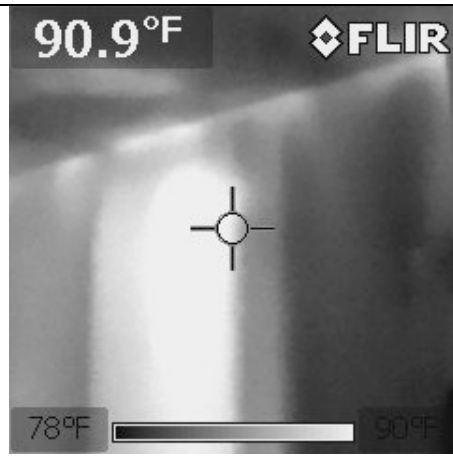
House connected to open duct chase in attic

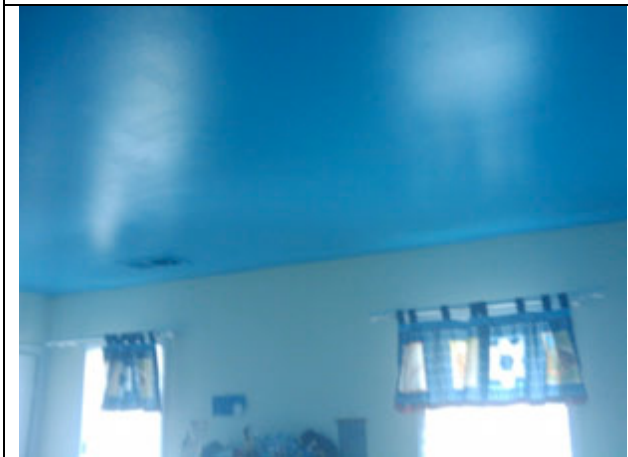
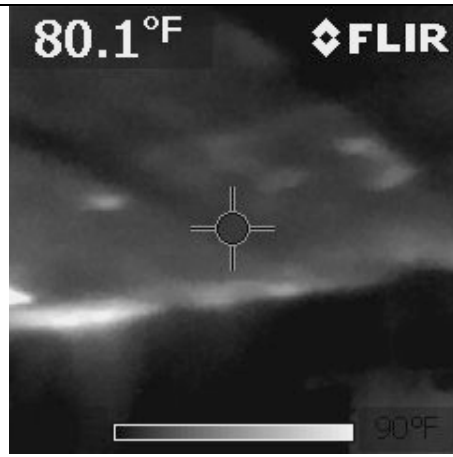
Duct connected to attic and thin insulation levels

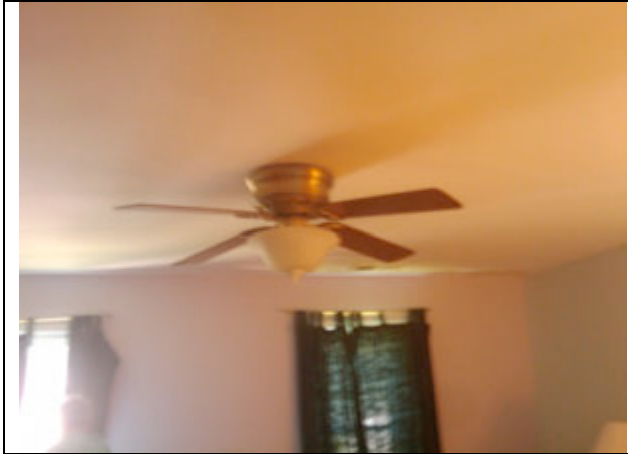
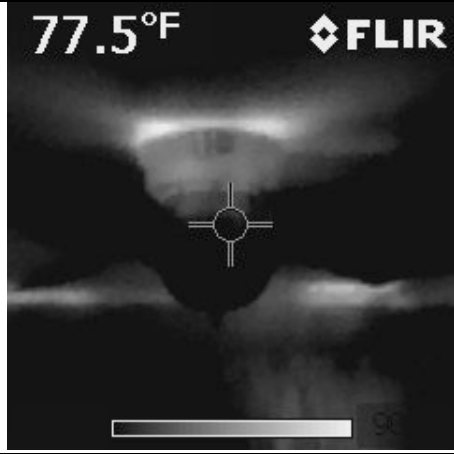
Electrical penetrations need air sealing

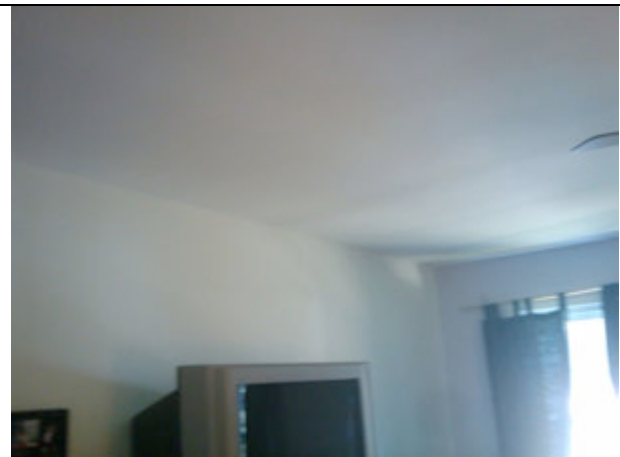
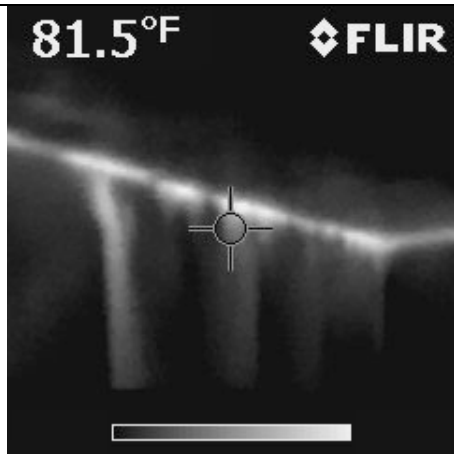
Wall top plates need sealing
