Home Energy Evaluation Report for House Five

House Five
Canterbury Woods Community
Annandale, VA

Inspection Date: June 10, 2010

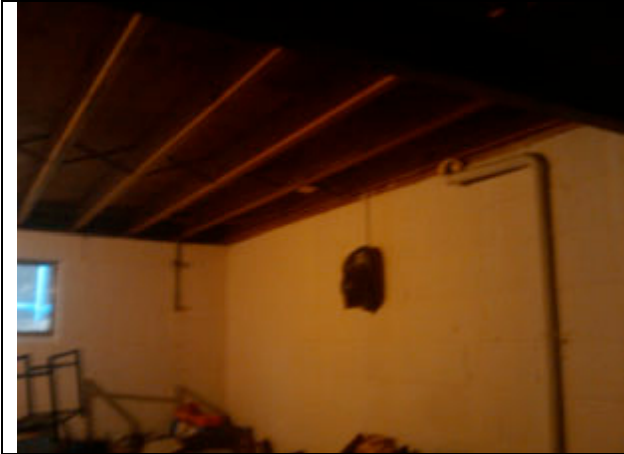
Air seal and insulate band joists

- 1) Spray foam band joist where accessible.
- 2) Seal ducts and pipes at floor penetrations in both lower basement and utility room chases.
- 3) Replace older windows with Energy Star qualified windows.

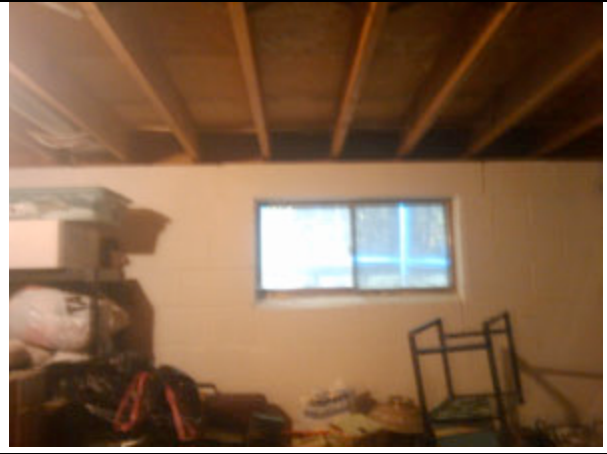
Air seal and insulate band joists

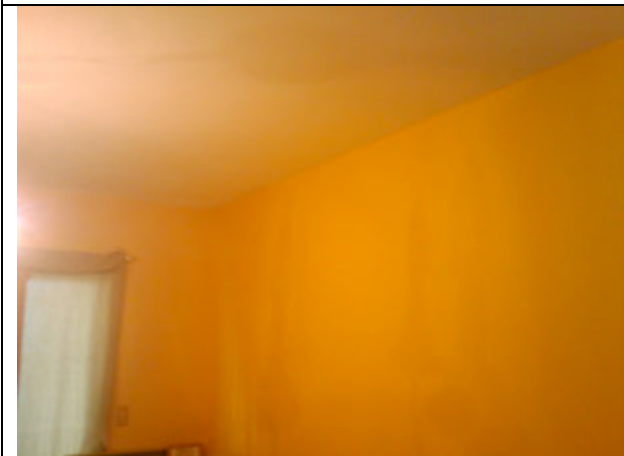
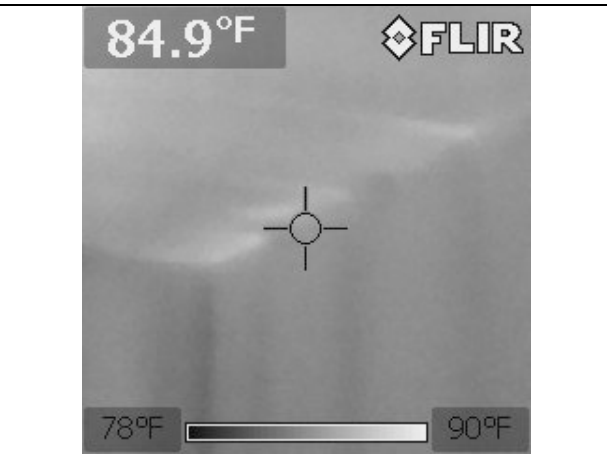
Air leakage at top plates of walls

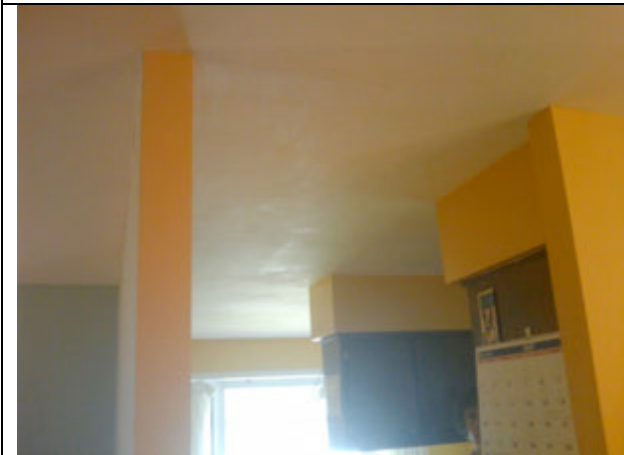
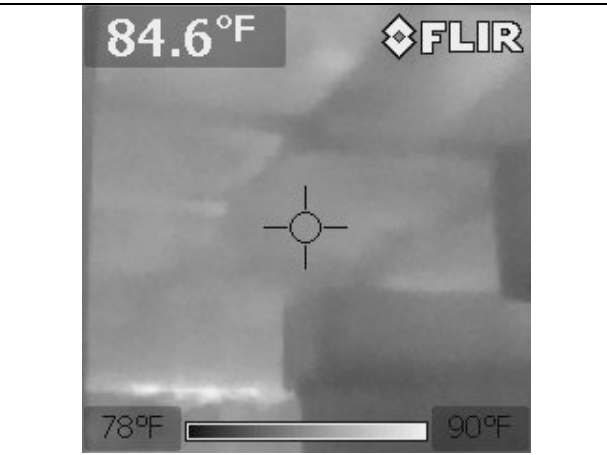
Thin insulation, air leakage at dropped ceiling

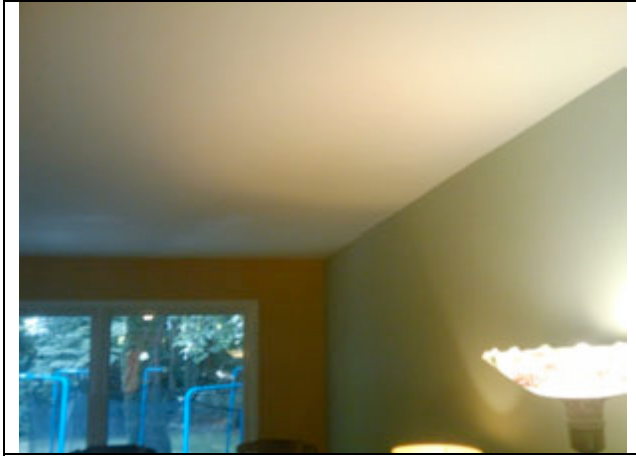
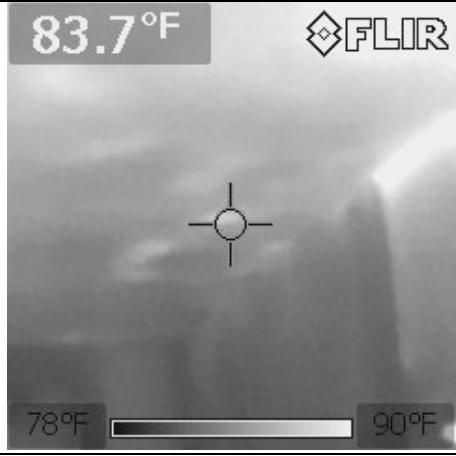
Thin insulation, air leakage at top plates

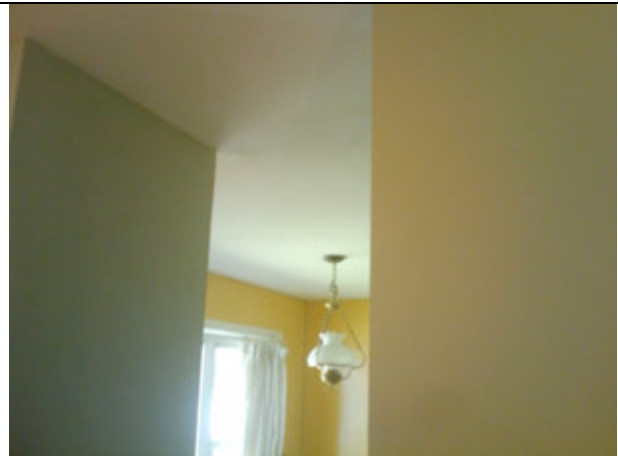
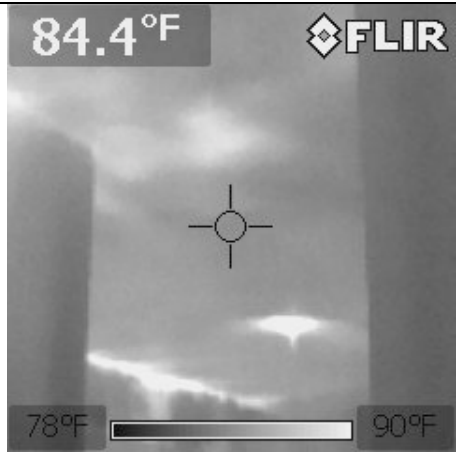
Thin insulation, wire box and top plate air leakage

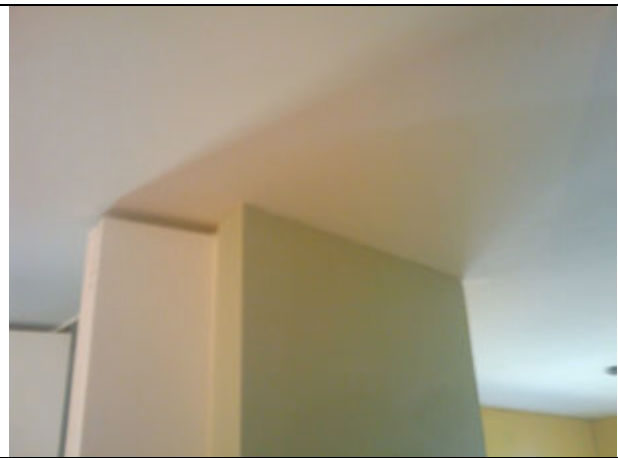
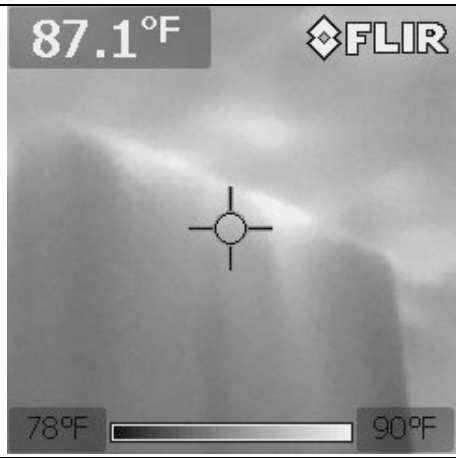
Seal top plates of walls and wire penetrations

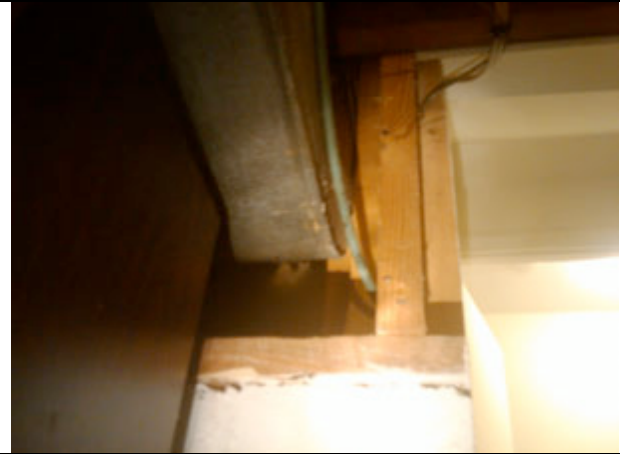
Open duct chase needs air barrier and sealing

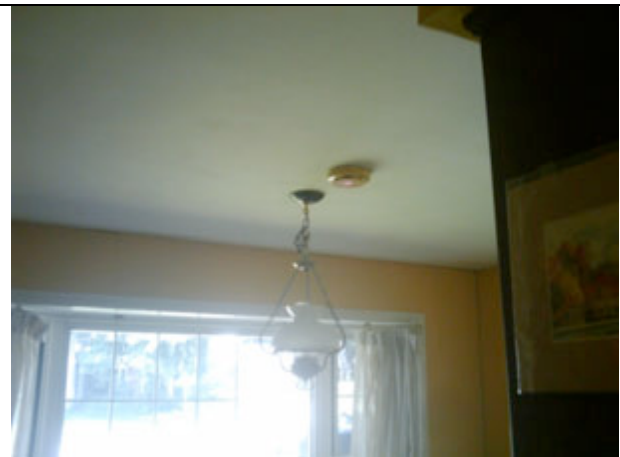
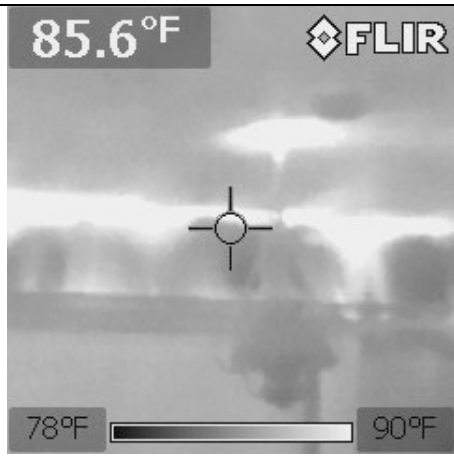
Air leakage at top plate and electrical penetrations

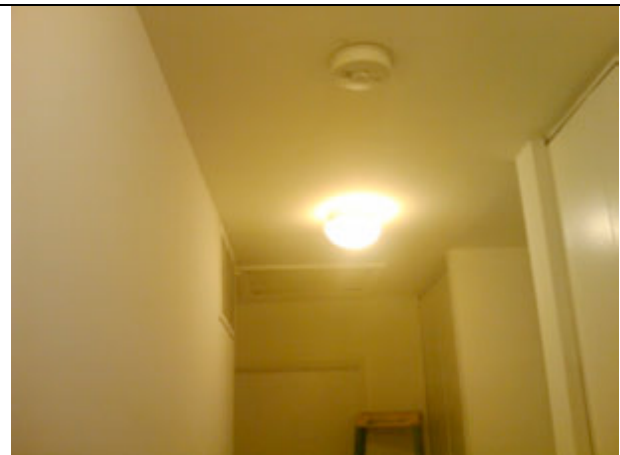
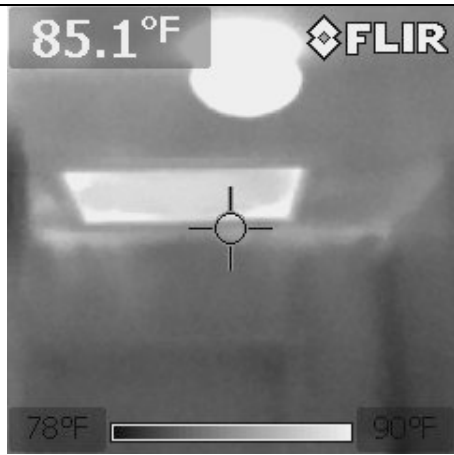
Air seal and insulate attic hatch

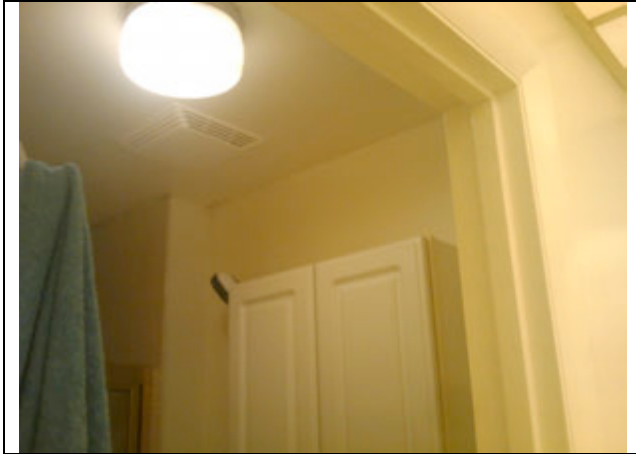
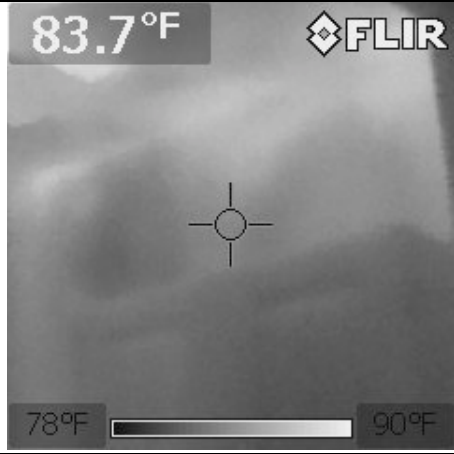
Air movement – top plates need air sealing

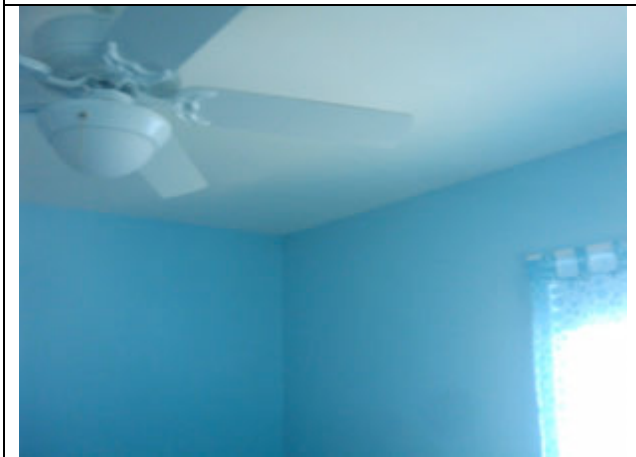
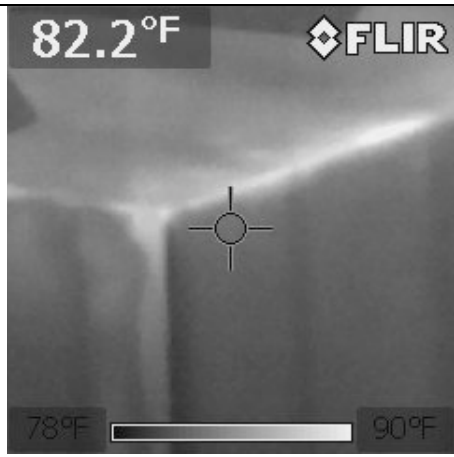
Air movement above bedroom

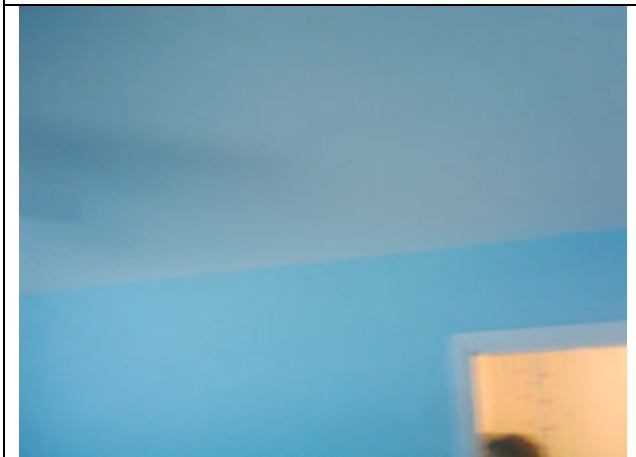
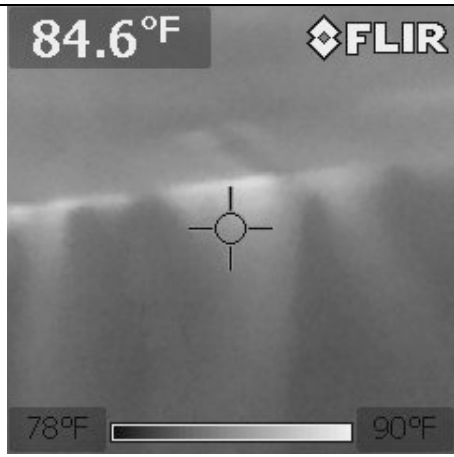
Top plate air sealing needed

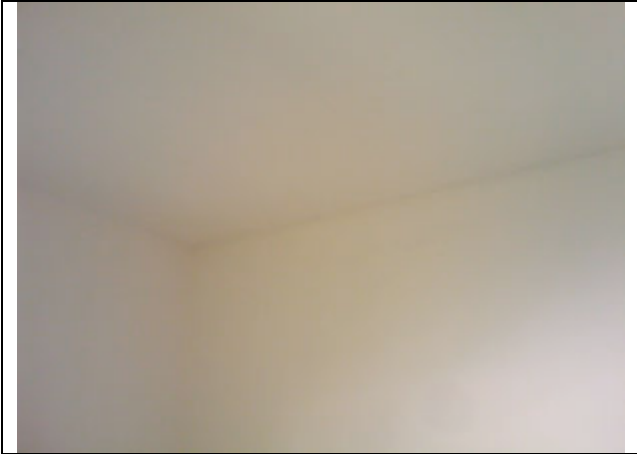
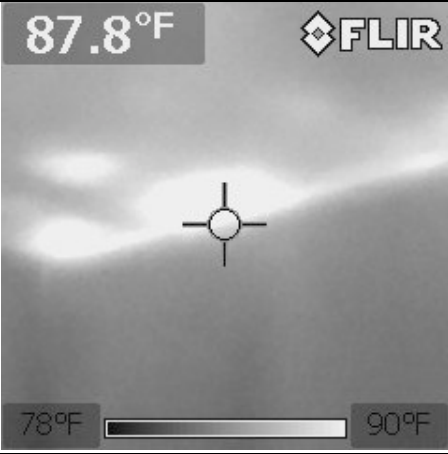
Little to no insulation
