Summary of Home Energy Assessments for Canterbury Woods Community Association

Summary

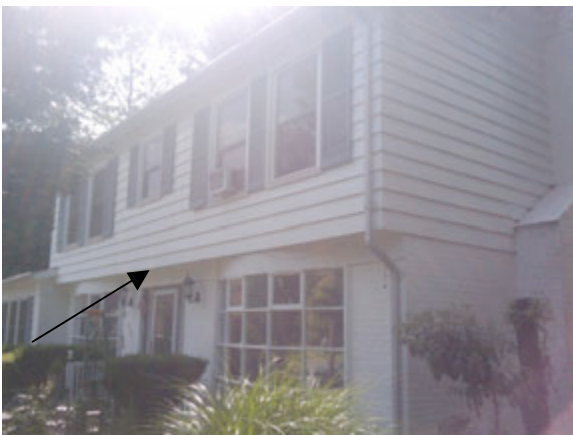
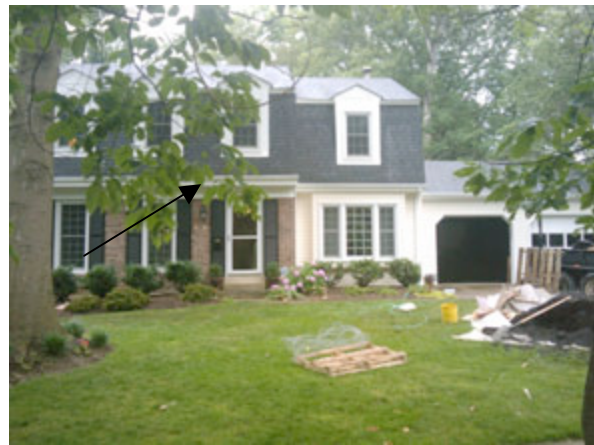
Cantilevered (overhanging) floors:

Two problems exist in these situations. The overhang is poorly insulated with pockets for air movement. Air will penetrate the home through the voids and the rooms above the overhang seem colder or warmer than the other rooms in the house. To aggravate this situation, the ducts that turn 90° twice create a resistance path to the conditioned air coming through the ducts. Duct leakage can also contribute to the temperature differences.

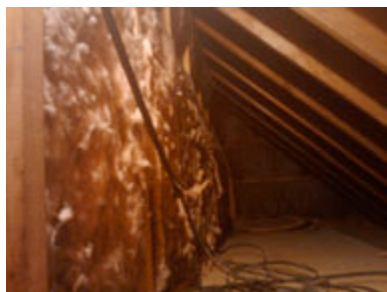
Attic Knee Walls:

The lack of an air barrier here allows air to flow freely through the insulation. Dirty insulation is an indication of air movement (the insulation is acting as a filter). Below these areas, the framing cavity is also open to allow air movement below this room to the attic (which is considered to be outside).

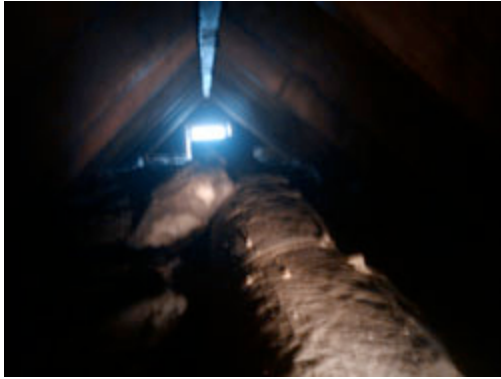
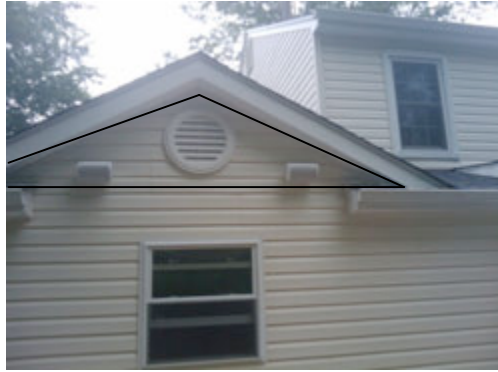
Small Hidden Attics:

Small hidden attics should be addressed on a case by case basis. The picture below on the left shows a space that is accessible, but will require additional time to work on. The picture below on the right is a small inaccessible attic. No major leakage was detected in this location and the work was performed just a few years ago. Our recommendation on this would be to leave it as is.

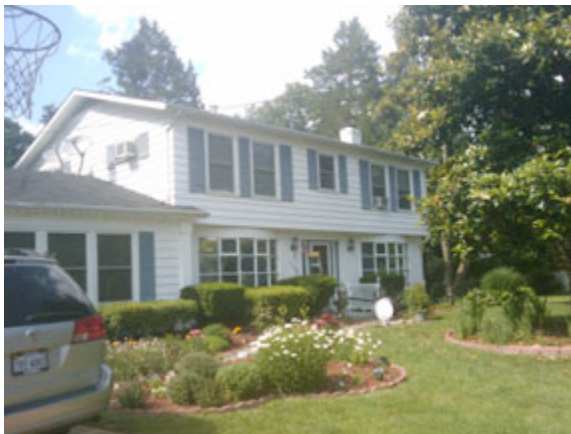
No Basement (slab on grade):

Uninsulated slabs account for up to 20% of the heat loss in a home. If the slab is on grade, the heat flows through the slab and escapes at the edges. Walk out basements have this problem as well. These rooms will often feel cold in the wintertime. Slabs can be insulated from the outside, but can be expensive and tricky to deal with aesthetically. Each case should be evaluated separately.
