# Home Energy Evaluation Report for House Two

House Two  
Canterbury Woods Community  
Annandale, VA

**Inspection Date:** June 9, 2010

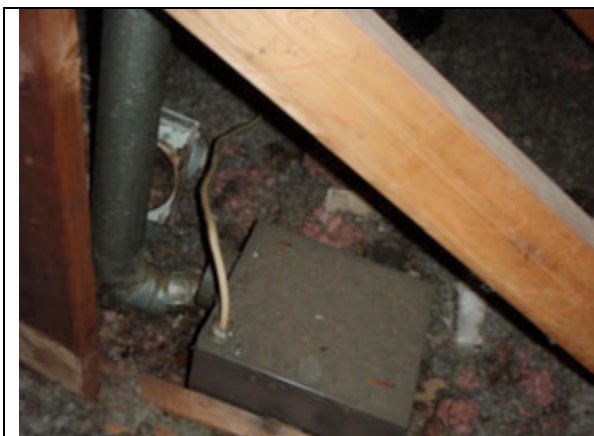
Disconnected bath exhaust fan

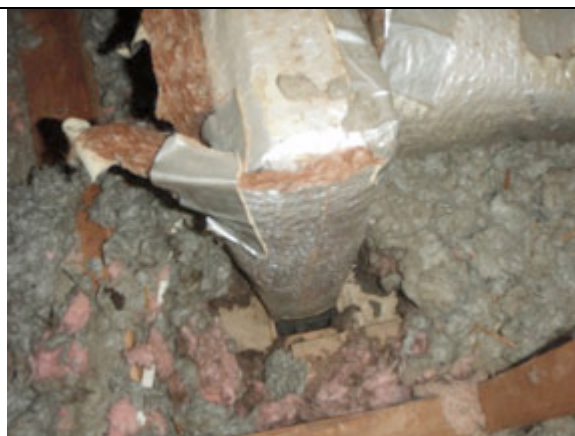
Thermal bypass at duct penetration

- 1) Disconnect roof fan or set on high setting to minimize operation.
- 2) Insulate and air seal attic hatch.
- 3) Seal exposed ducts.
- 4) Air seal attic floor and insulate to R-49. We recommend borate stabilized cellulose.

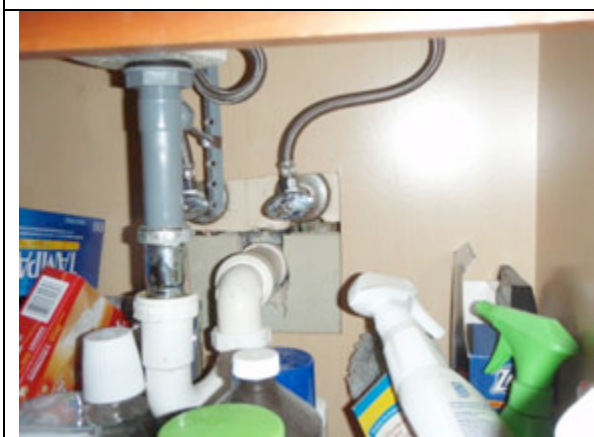
Air leakage at plumbing penetrations

- 1) Install transfer grille between the basement and 1<sup>st</sup> floor to increase circulation of air in the basement.
- 2) Seal duct and plumbing chases where accessible
- 3) Seal band joist where accessible
